# The Twenty-first Regular Report

## Conservation of the Flat Roofs at the National Mosque, Kuala Lumpur, Malaysia

A Ghafar Bin Ahmad, *Professor*

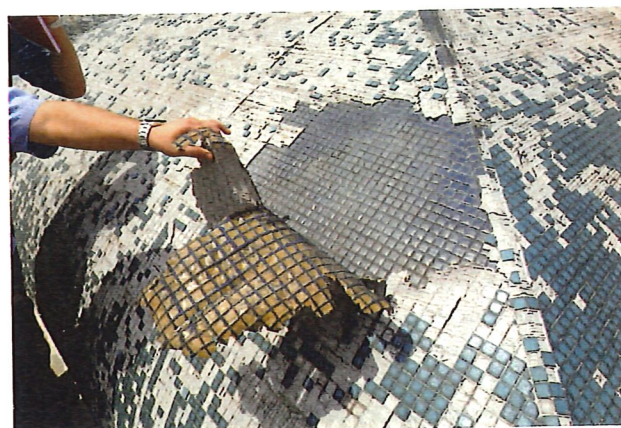
The ageing top layer of glazed porcelain mosaics on the domes of the National Mosque were found to be either missing, detached, loosened or to have fallen off, exposing the old layer of waterproofing coating and the original mosaics. This condition had caused water penetration, trapped moisture and roof leakage onto the prayer halls and other spaces underneath the flat roofs.

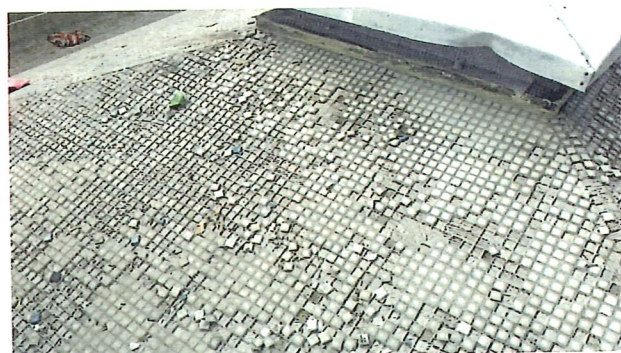
Similar to the domes, the glazed porcelain mosaics on the pyramid roofs were found to be either missing, detached, loosened or to have fallen off, exposing the old layer of waterproofing coating.

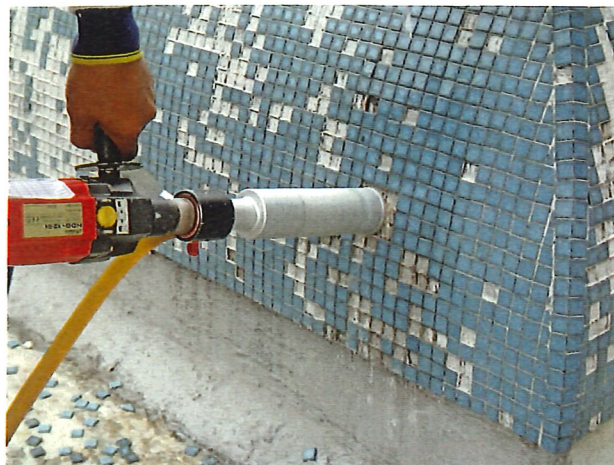
Samples of building materials from the domes including concrete substrate or structure were cored to examine the mineralogical and chemical characteristics (petrography test); and also to determine the elemental composition (X-ray fluorescence test).

A petrographic test is a microscopic method used to examine the mineralogical and chemical characteristics of rocks or concrete samples. These samples can be taken from lump samples or cores. Samples of original mosaics and mortar or plaster on the domes and pyramid roofs of the National Mosque were extracted and subjected to petrographic testing to determine their composition and condition such as type of binder, distribution of aggregates including shape and size distribution, pore characteristics, binder-aggregates interface or bond, secondary reaction, salt formation, cracks and fissures. The petrographic testing was carried out using a combination of different microscopy from stereo zoom microscopes to digital microscopes to a magnification of 500x on hand and polished sections. Thin sections were prepared for examination with a polarising and fluorescent microscope (PFM) under transmitted and reflected light.

X-ray florescence (XRF) testing is a non-destructive analytical technique used to determine the elemental composition of building materials such as concrete, plaster and mortar. It is a process whereby electrons are displaced from their atomic orbital position, releasing a burst of energy that is characteristic of a specific element. An XRF analyser determines the chemistry of a sample by measuring the fluorescent (or secondary) X-rays emitted from a sample when it is excited by a primary X-ray source. Results from the XRF tests were very important and useful to propose new building materials on the flat roofs.

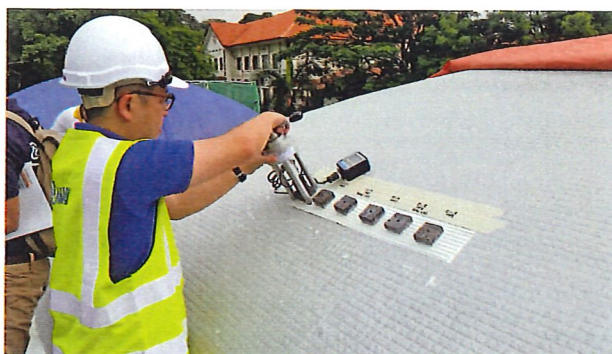
In-situ pull-off adhesive tests were carried out on the dome to determine the bond strength of "Kerapoxy" epoxy tile adhesive between the polyurea coating surface and the existing mosaic layer. The result showed that the average bond strength was 2.5 N/mm<sup>2</sup>, which was acceptable.

In-situ pull-off adhesive tests were carried out on the domes to determine the bond strength of "Kerapoxy" epoxy tile adhesive between the polyurea coating surface and the existing mosaic layer. A pull-off tester was used for the test and the bond value was determined by taking the load at failure divided by the dolly area which was adhered on the tile. The average bond strength was 2.5 N/mm<sup>2</sup> which was

acceptable. The failure mode was also observed and it was found that all test specimens failed at the existing substrate but not at the new epoxy adhesive bond interface. This indicated that the bonding strength of the new epoxy adhesive was stronger against the original substrate or structure.

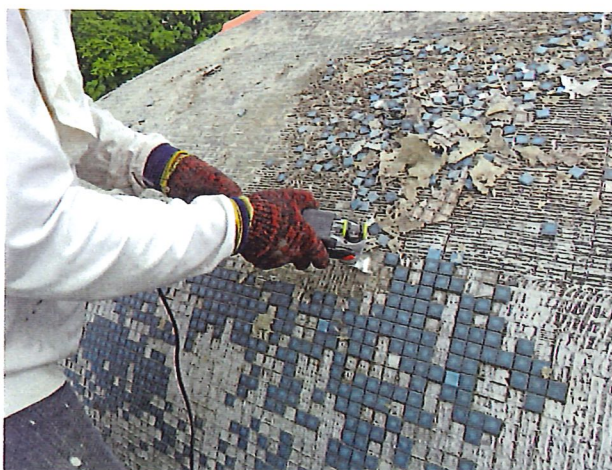
An oscillating tool was used to carefully remove the outer-most or non-original layer of glazed porcelain mosaics on the domes and pyramid roofs until the existing original layer of waterproofing coating was found. The tool reduced the vibration and noise pollution disturbing the public and the conduct of prayers inside the mosque.

1. The mosaic-finished dome and pyramid roofs:
  - i. Entirely remove the outer-most or non-original layer of glazed porcelain mosaics until the existing original layer of waterproofing coating is found by using an oscillating tool. The tool reduces the vibration and noise pollution to a minimum. It provides the least level of disturbance or nuisance to the public or the conduct of prayers inside the mosque.

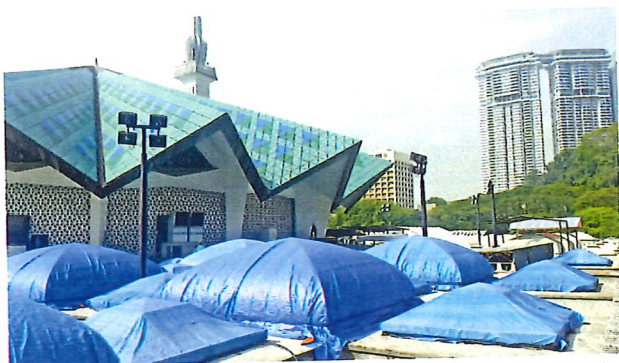
Canvas sheets were used to cover the domes and pyramid roofs after the outer-most layer of glazed porcelain mosaics had been removed. This was to protect the exposed surfaces from water penetration.

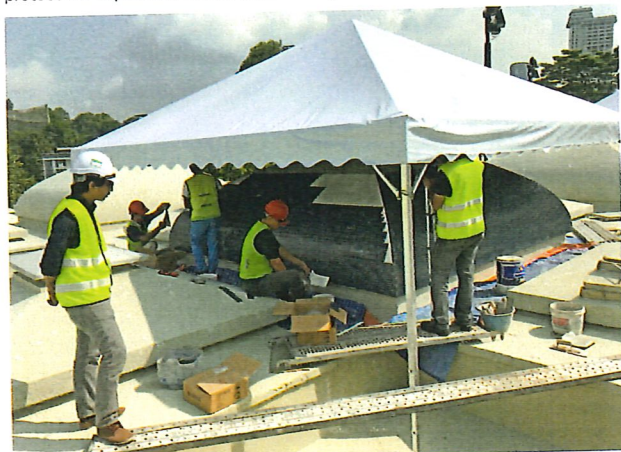
Temporary tents were erected to cover each dome and pyramid roof during the mosaic installation stage in order to protect them from direct sunlight and heavy rain.

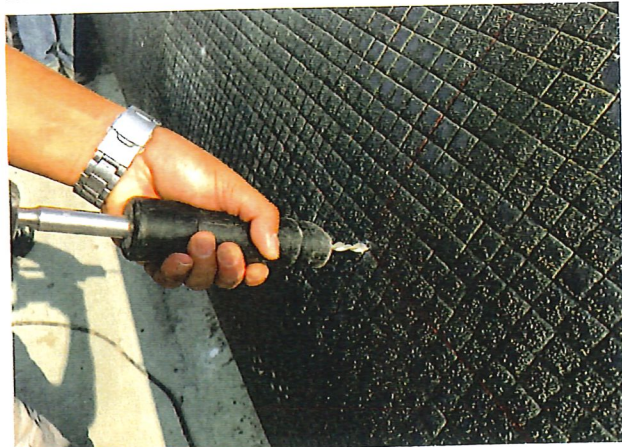
Rehabilitation of the reinforced concrete structure or substrate of the domes was carried out by driving 8 mm-diameter "Helifix-Dryfix" stainless steel helical pins through the pilot holes and into the reinforced concrete structure or substrate.

- i. Delaminated cementitious bedding render underneath the mosaic finish for dome and pyramid roofs to be anchored mechanically into the reinforced concrete structure by using the "Helifix-DryFix" stainless steel helical pinning system.
- ii. Drill 6.5 mm-diameter pilot holes through the bedding render into the reinforced concrete structure or substrate to a depth of 40 mm and at 450 mm intervals.
- iii. Drive 8 mm-diameter "Helifix-Dryfix" stainless steel

helical pins through the pilot holes and into the reinforced concrete structure or substrate to secure and anchor the render mechanically.

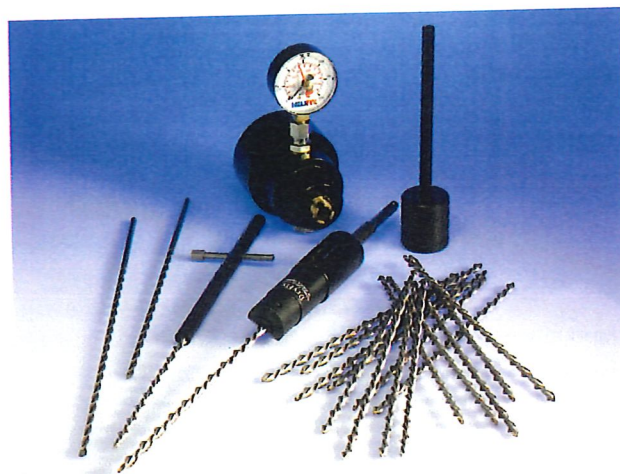
Equipment used to secure and anchor the reinforced concrete substrate or structure of the domes and pyramid roofs, including a load tester, stainless steel DryFix tie-pins and pin drivers.

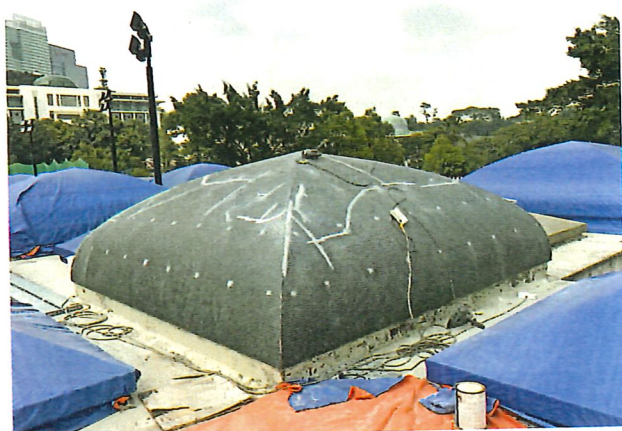
The dome after completion of work using the "Helifix-DryFix" stainless steel helical pinning system.

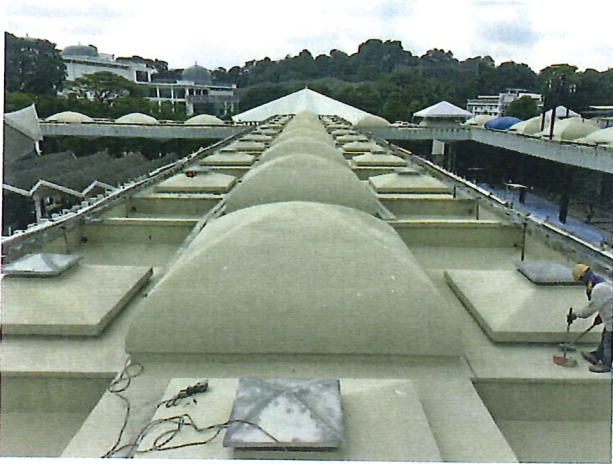
The flat roofs of the National Mosque covered by polyurea waterproofing coating.

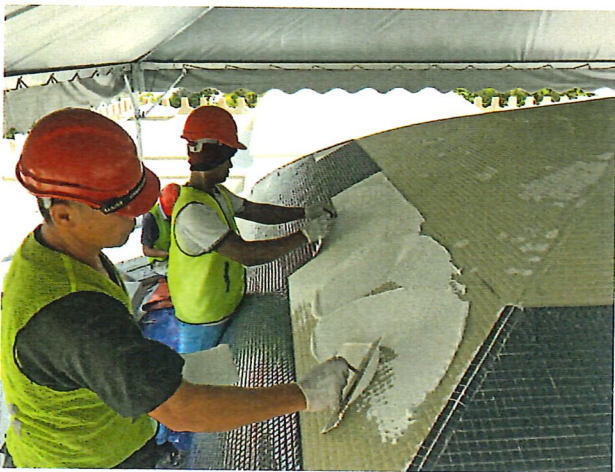
Spreading the tile adhesive on the surfaces of the dome by using a notched trowel before layering the sheet of glazed porcelain mosaics.

- iii. Spread the tile adhesive on the surfaces of domes and pyramid roofs by using a notched trowel.
- iv. Place the mosaic sheet firmly into the wet adhesive. Push the mosaic back and forth to collapse the mortar ridges in order to achieve maximum coverage.

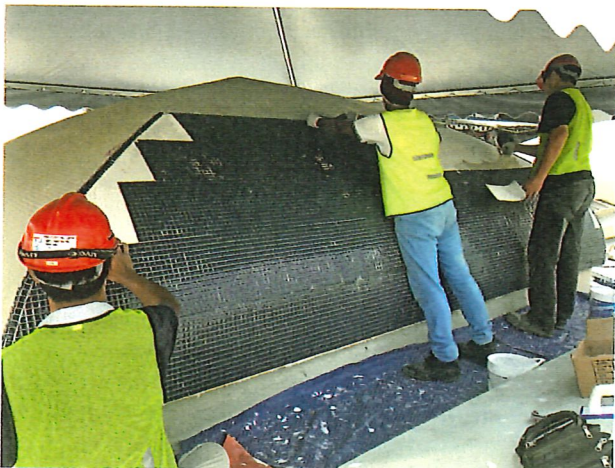
The installation of new glazed porcelain mosaics on the dome was carried out from the bottom layer and working upwards.

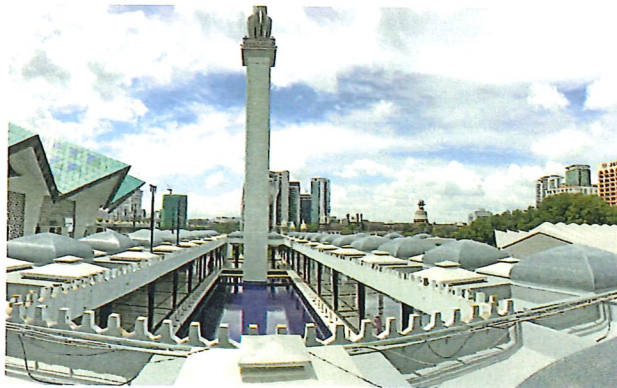
Upon completion, a total of 13,482,953 new glazed porcelain mosaic pieces were used to cover 95 domes and 270 pyramid roofs on the flat roofs of the National Mosque.

- xi. A total of 13,482,953 new glazed porcelain mosaic

pieces were used to cover 5,302 m<sup>2</sup> of the surface areas of the domes and the pyramid roofs (2,553.6 m<sup>2</sup> for the domes and 2,748.4 m<sup>2</sup> for the pyramid roofs).

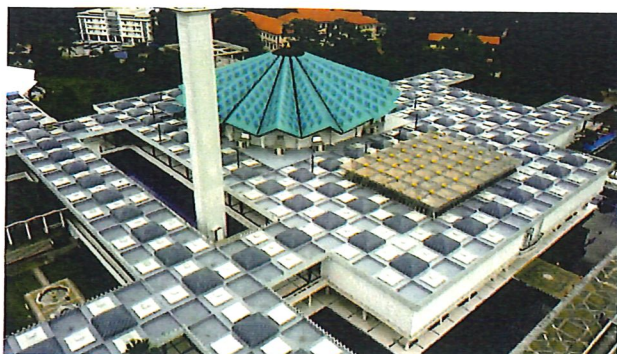
An aerial view of the National Mosque with its newly conserved flat roofs.
